Corrosion Resistance

NIC Industries Quality Control Group

Purpose: Evaluate the corrosion resistance of Teflon and Xylan coated bolts versus Cerakote E-100 Blackout coated bolts.

Test Method: Standard Practice for Operating Salt Spray (Fog) Apparatus ASTM B117 and Standard Practice for Evaluating Degree of Rusting on Painted Steel Surfaces ASTM D610

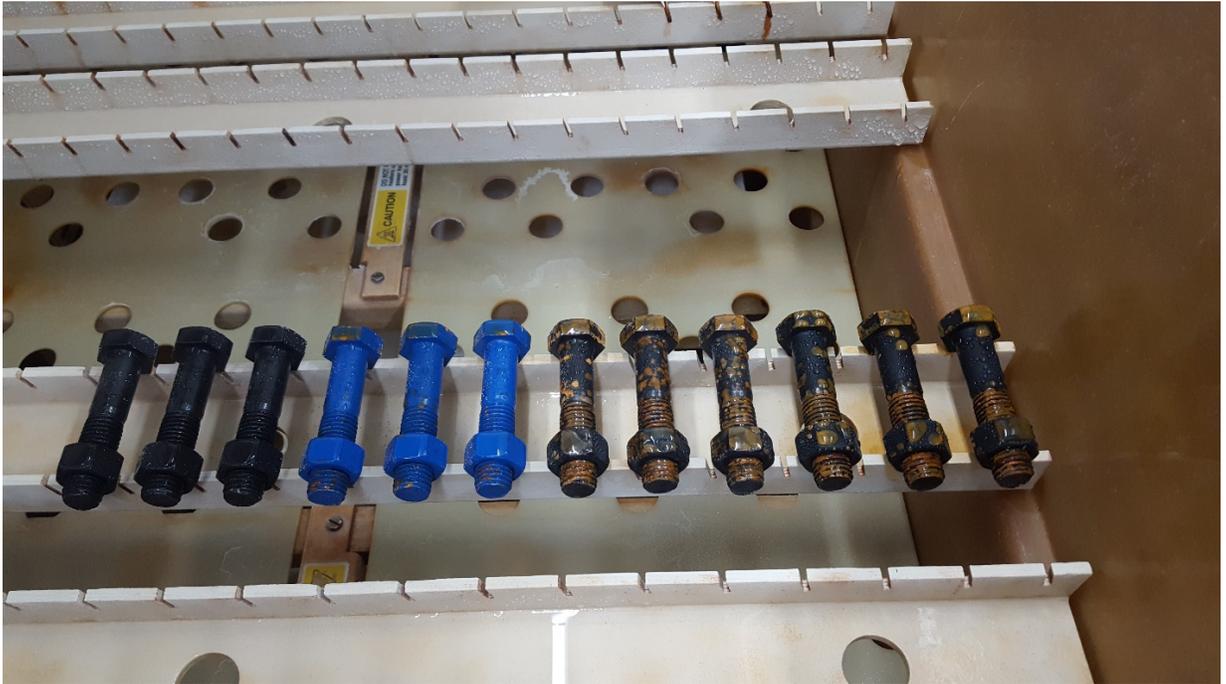
Photo 1. All four coatings in salt fog chamber at 24 hours.

Rust was observed on both Teflon and Xylan bolts after 24 hours in the salt fog chamber. Per Cerakote standard ASTM D610 Teflon Metallic reached 3% red-rust and was left in the chamber for later comparison. At 48 hours, Teflon Black reached 3% red-rust and was also left in chamber for later comparison. Zero rust was observed on Cerakote bolts and nuts. Photo 1 depicts the amount of rust visible at 24 hours, while Photo 2 shows the Teflon Metallic bolts at the end of the 24 hour

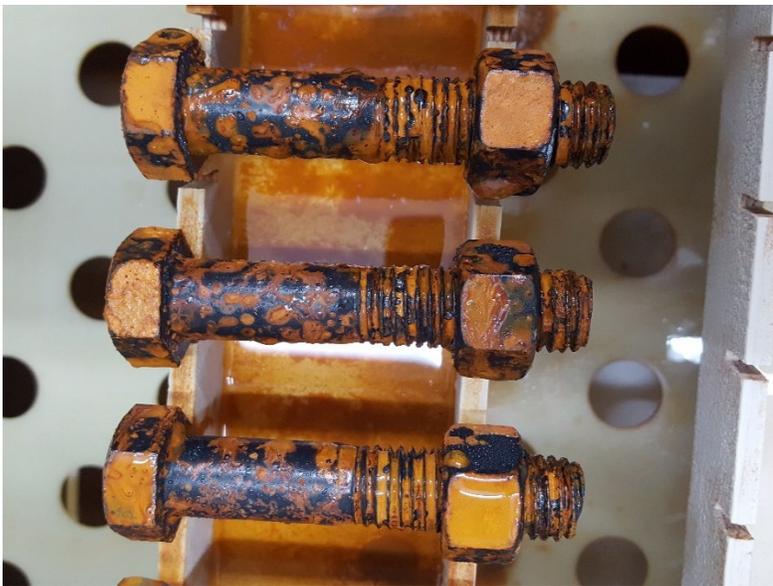
Photo 2. Teflon Metallic red-rust at 24 hours.

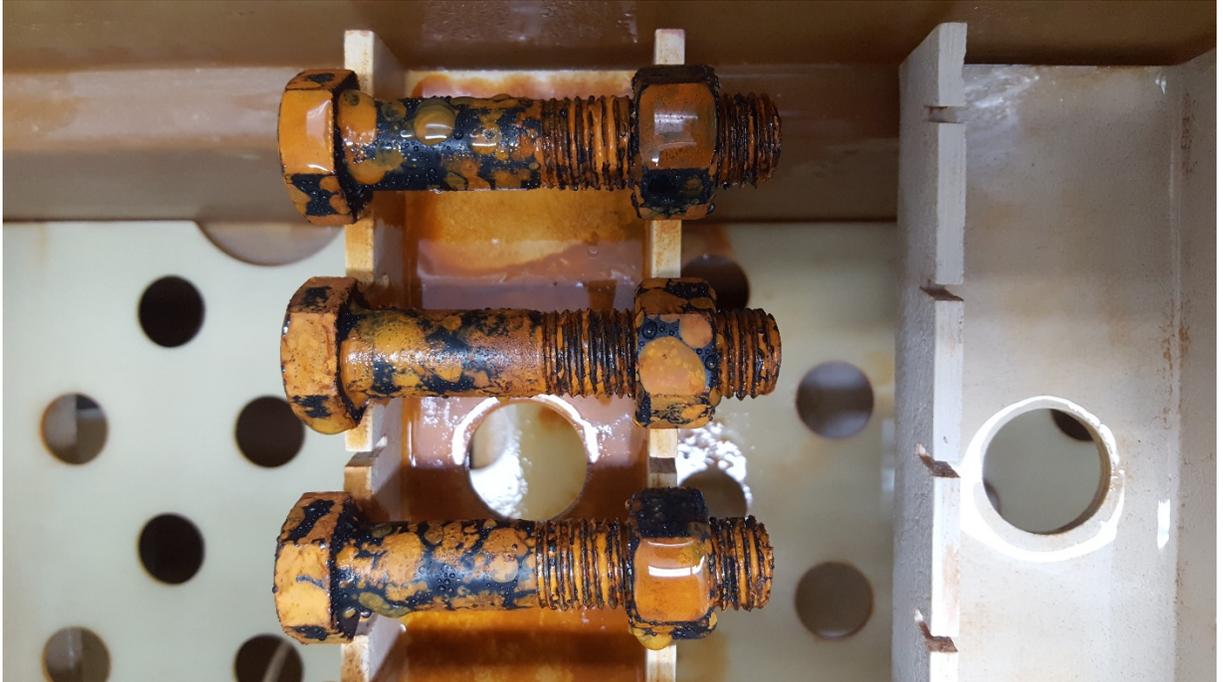
Photo 3. Teflon Black red-rust at 48 hours.

period. Photo 3 illustrates the amount of corrosion on the Teflon Black bolts at 48 hours.

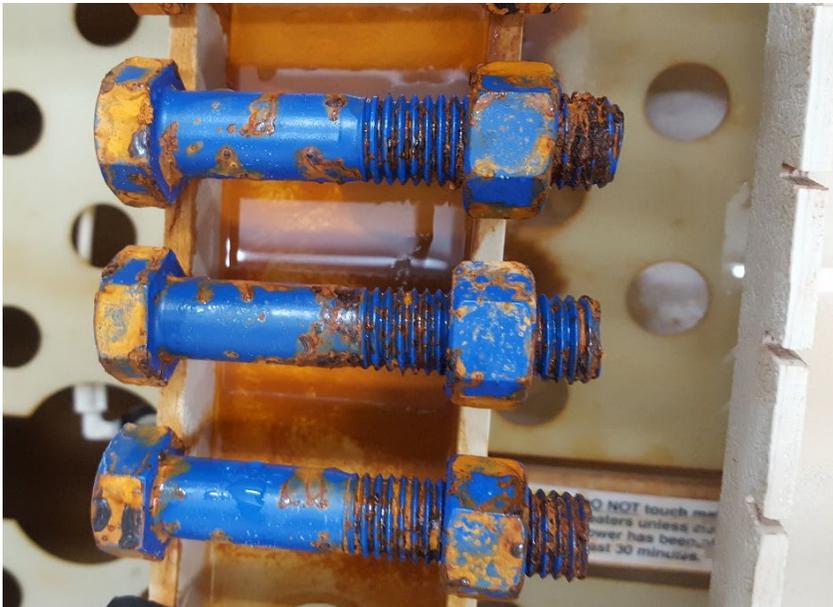
Photo 4. Xylan red-rust at 540 hours.

At 540 hours, Xylan reached per Cerakote Standard ASTM D610 of 3% red-rust on body of bolt and left in chamber for later comparison. Photo 4 shows the level of corrosion of Xylan at 540 hours. Photo 5 provides the appearance of all bolts at 540 hours.

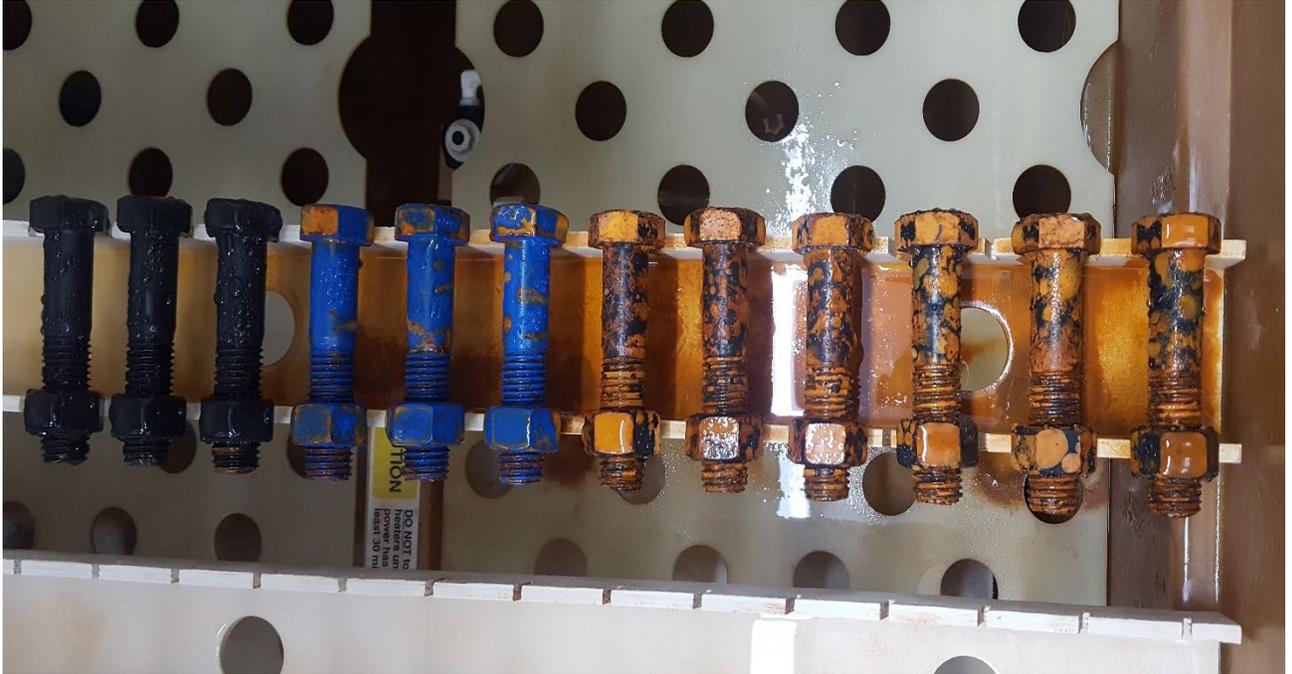
Photo 5. All bolts at 540 hours in chamber.

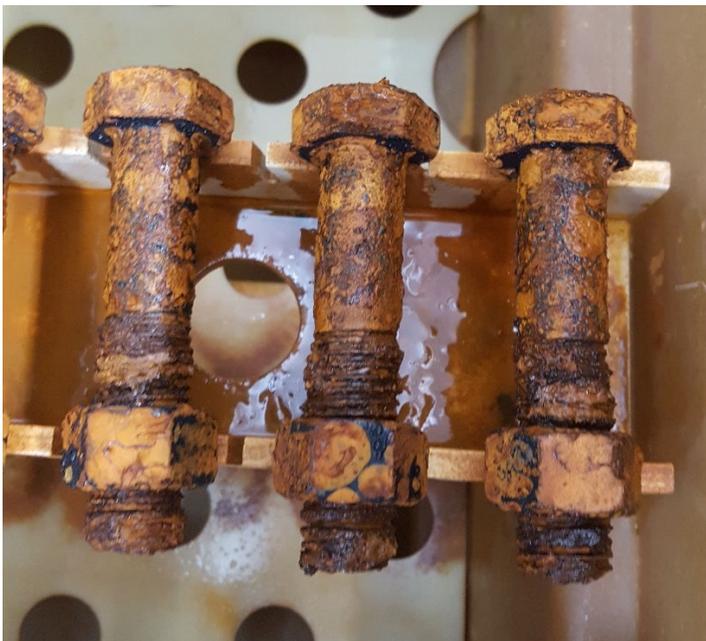
Photo 6. Teflon Black at 619 hours.

Teflon Black and Teflon Metallic black were pulled from experiment at 640 hours due to excessive corrosion. Photos 6, 7, 8 and 9 depict how the Teflon Black, Teflon Metallic, Xylan and Cerakote bolts, respectively, appeared at 619 hours. Cerakote and Xylan were left in chamber to complete the analysis.

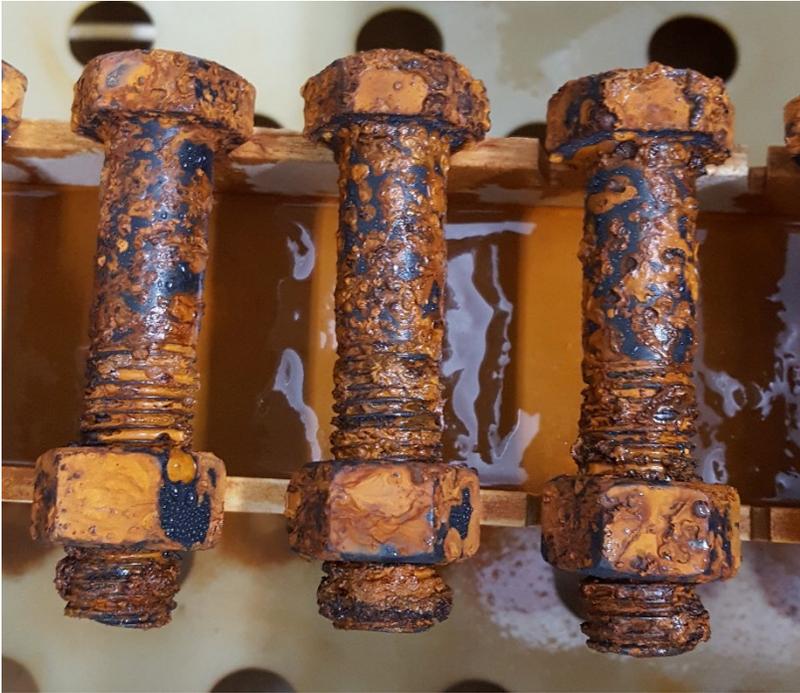
Photo 7. Teflon Metallic Black at 619 hours.

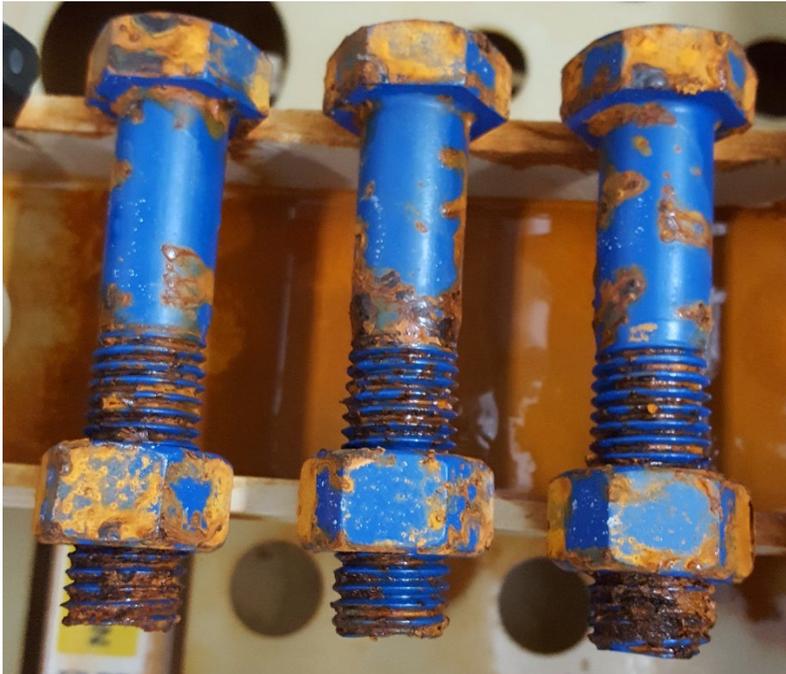
Photo 8. Xylan at 619 hours.

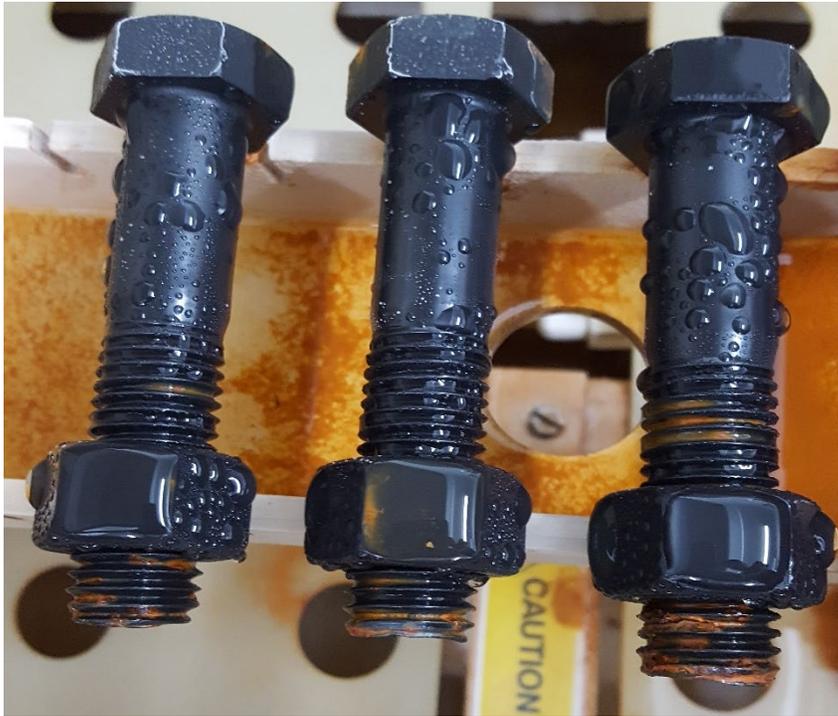
Photo 9. Cerakote Blackout at 619 hours.

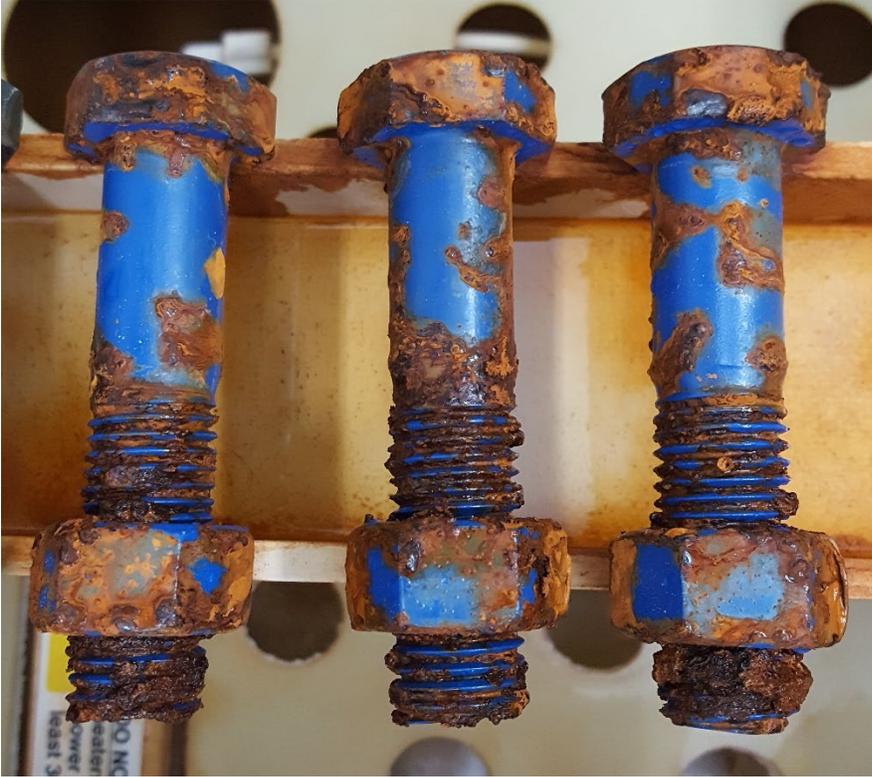
Photo 10. Xylan at 1500 hours.

The Xylan bolts were pulled from chamber at 1871 hours due to excessive corrosion. Photos 10 and 11 were taken of Xylan and Cerakote Blackout, respectively, at 1,500 hours for comparison.

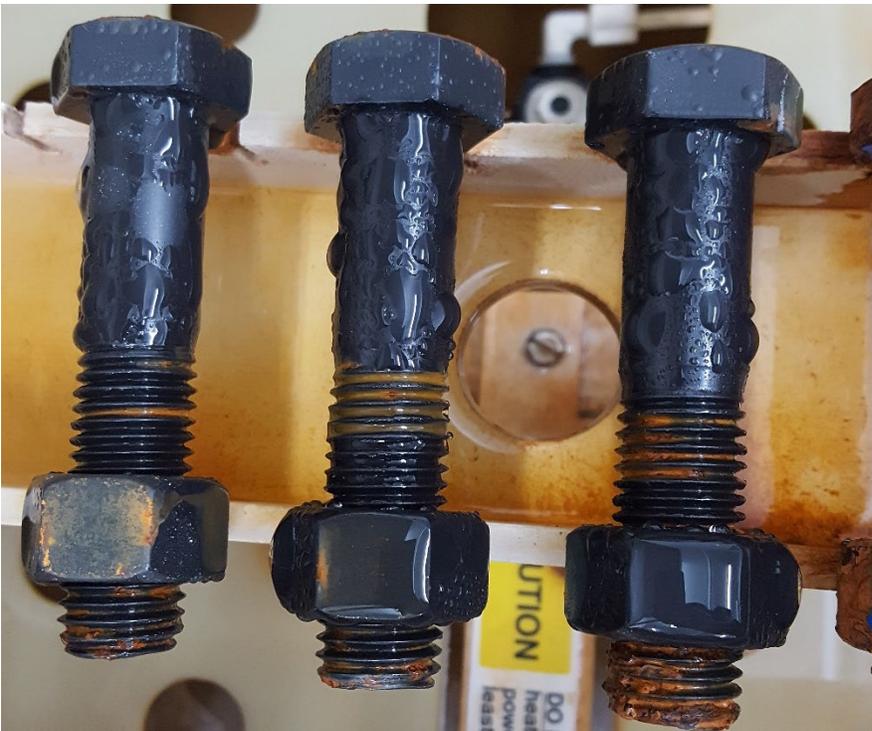
Photo 11. Cerakote Blackout at 1500 hours.

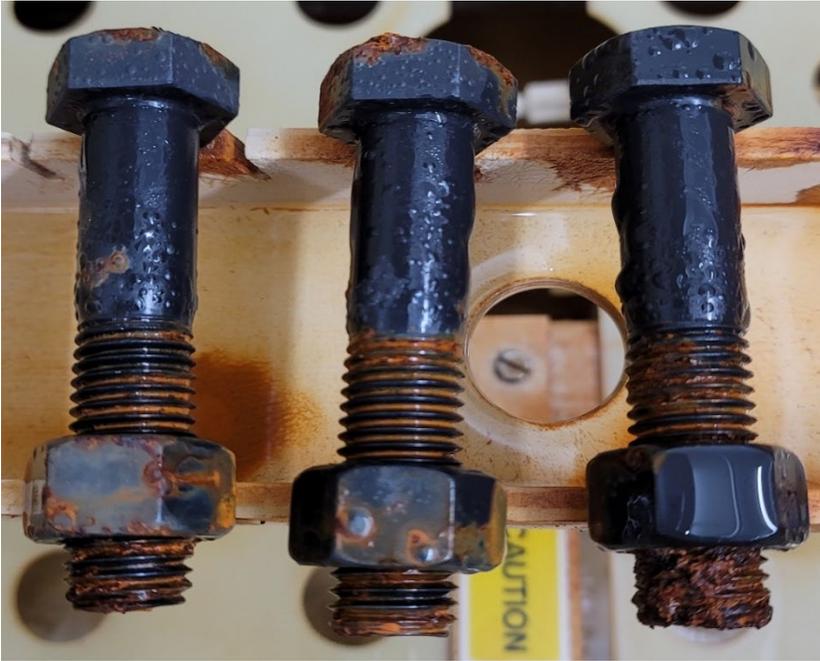
Photo 11. Cerakote Blackout at 3,963 hours.

Cerakote had not reached 3% red-rust at 4000 hours and the test was concluded. Photo 11 shows Cerakote Black out 3,963 hours, which Photo 12 displays all bolts comparatively at the end of the analysis.

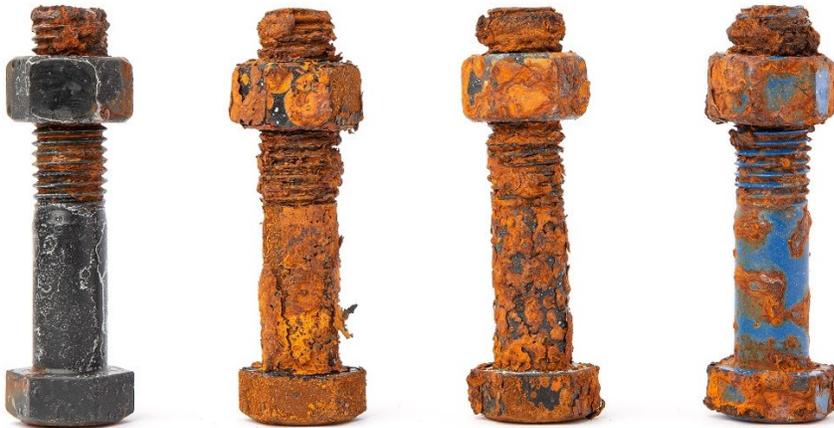
Photo 12. Corrosion levels of Cerakote Blackout after 4,000 hours, Teflon Black and Teflon Metallic Black after 640 hours, and Xylan after 1871 hours.
